Coal - Underground Fatalities Second Half - 1990

U.S. Department of Labor
Mine Safety and Health Administration

ABSTRACTS WITH ILLUSTRATIONS

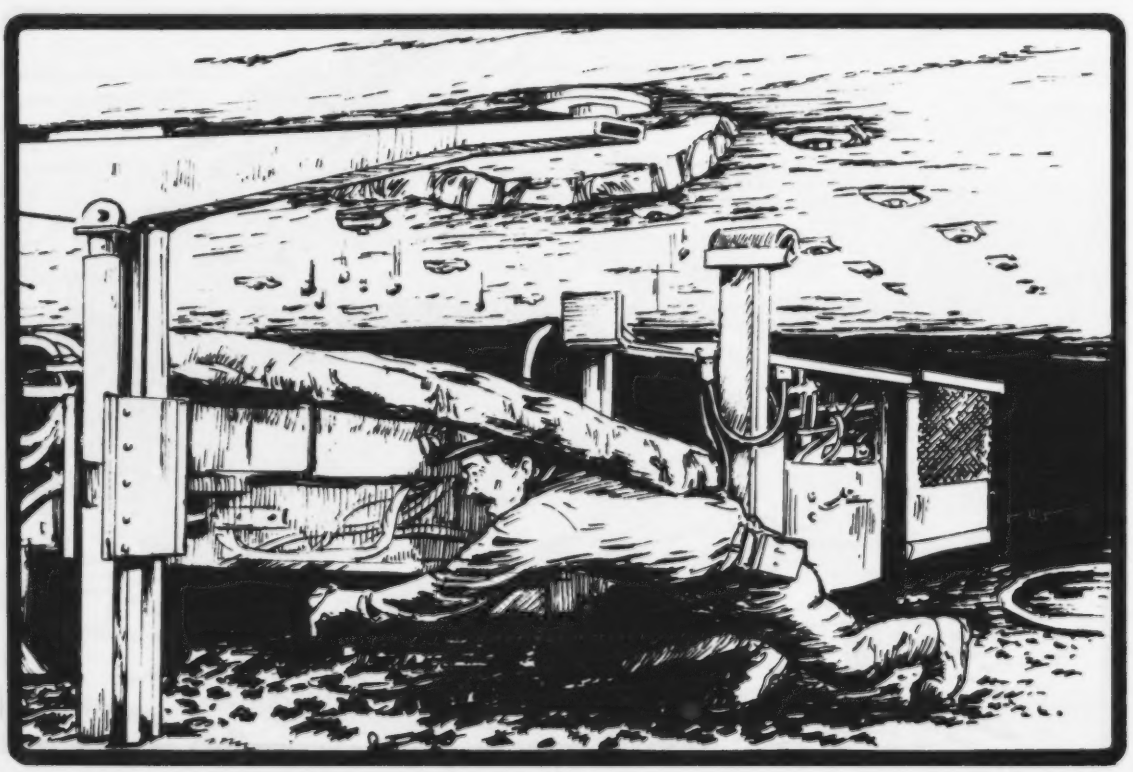
A roof bolting machine operator was drilling a hole in the roof preparing to install a roof bolt inby the last row of permanent roof supports. He was using a roof bolting machine equipped with a T-bar type ATRS system. While he was changing a drill steel, an undetected piece of cap rock fell between the outby edge of the ATRS and the canopy over the drill controls, just inby the last row of bolts. The cap rock struck the victim causing fatal injuries.

1. Where the mining height permits and the visual examination does not disclose a hazardous condition, sound and vibration roof tests, or other equivalent tests, shall be made where supports are to be installed.
2. The roof bolting machine was not equipped with a canopy installed in such a manner that the operator was protected from falls of roof when at the drill controls.

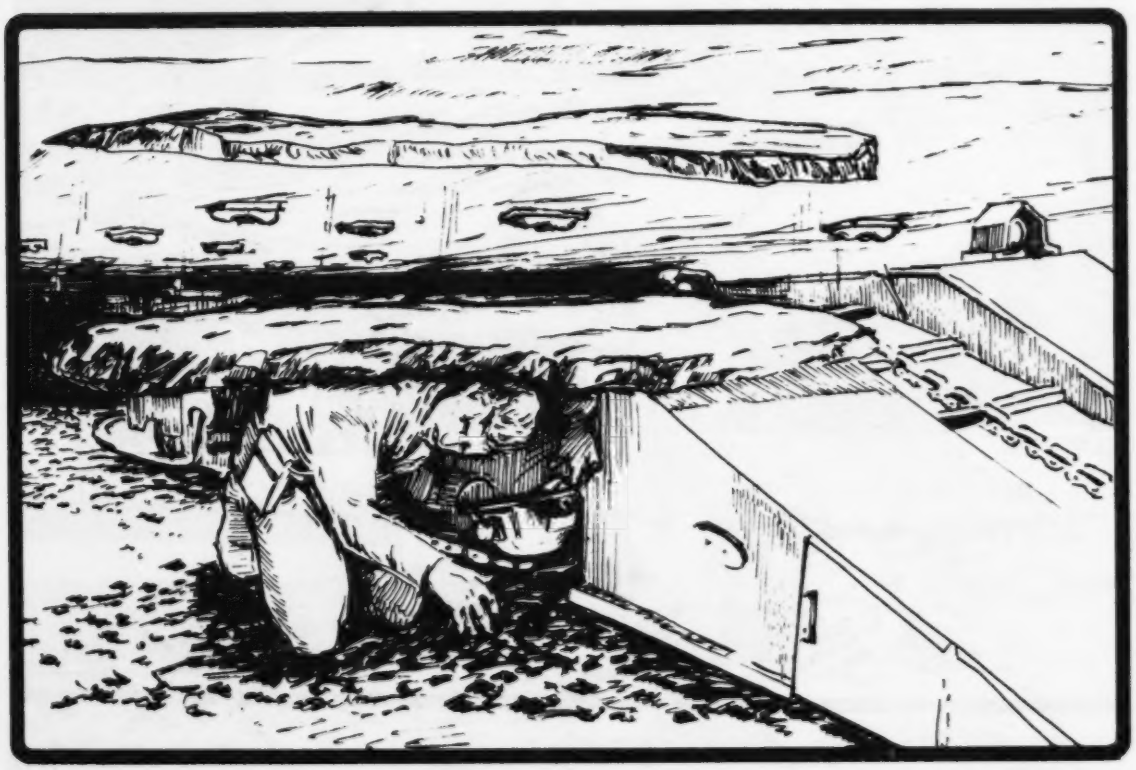
A loader operator was moving the loader toward the face preparing to load coal. A piece of draw rock, approximately five feet long, three and one-half feet wide and from two to five inches thick, fell from the roof onto the loader operator. The loader operator had gone inby permanent roof support approximately three feet.

Means of Prevention
Never proceed inby permanent roof supports.

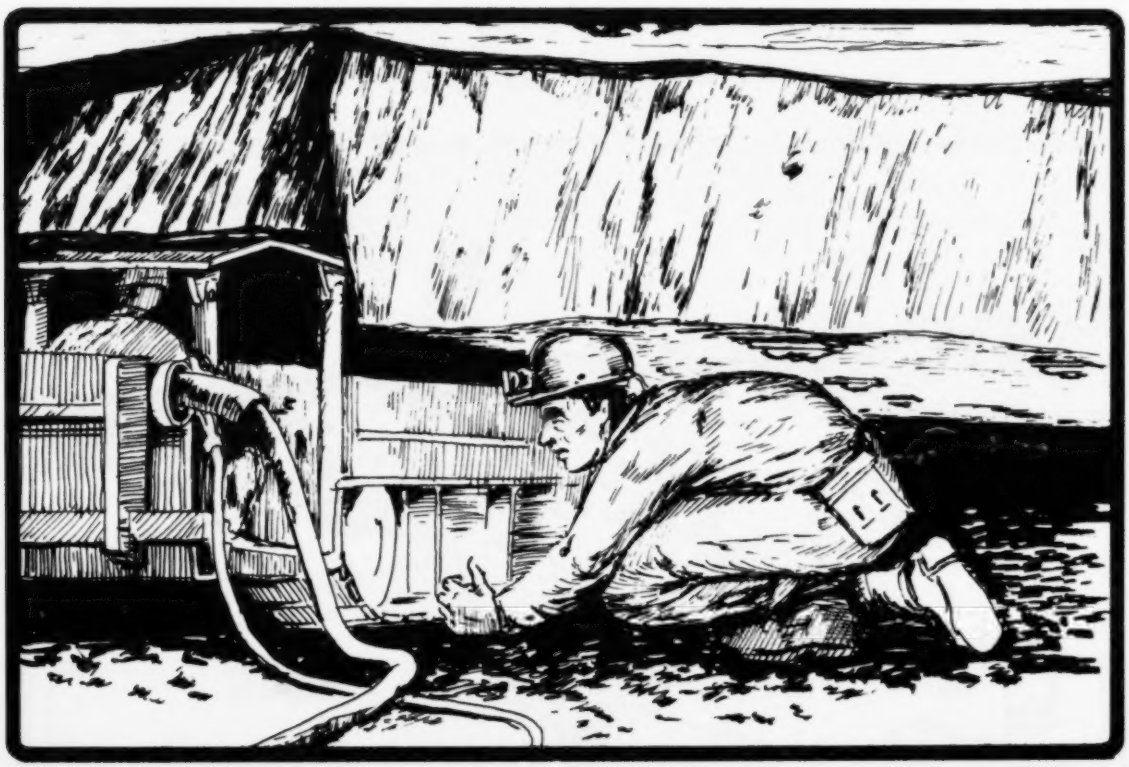
A continuous miner helper was caught under a massive roof fall during pillar recovery and was fatally injured.

1. Always comply with the approved roof control plan.
2. Do not conduct full and partial pillar recovery on the same pillar line.

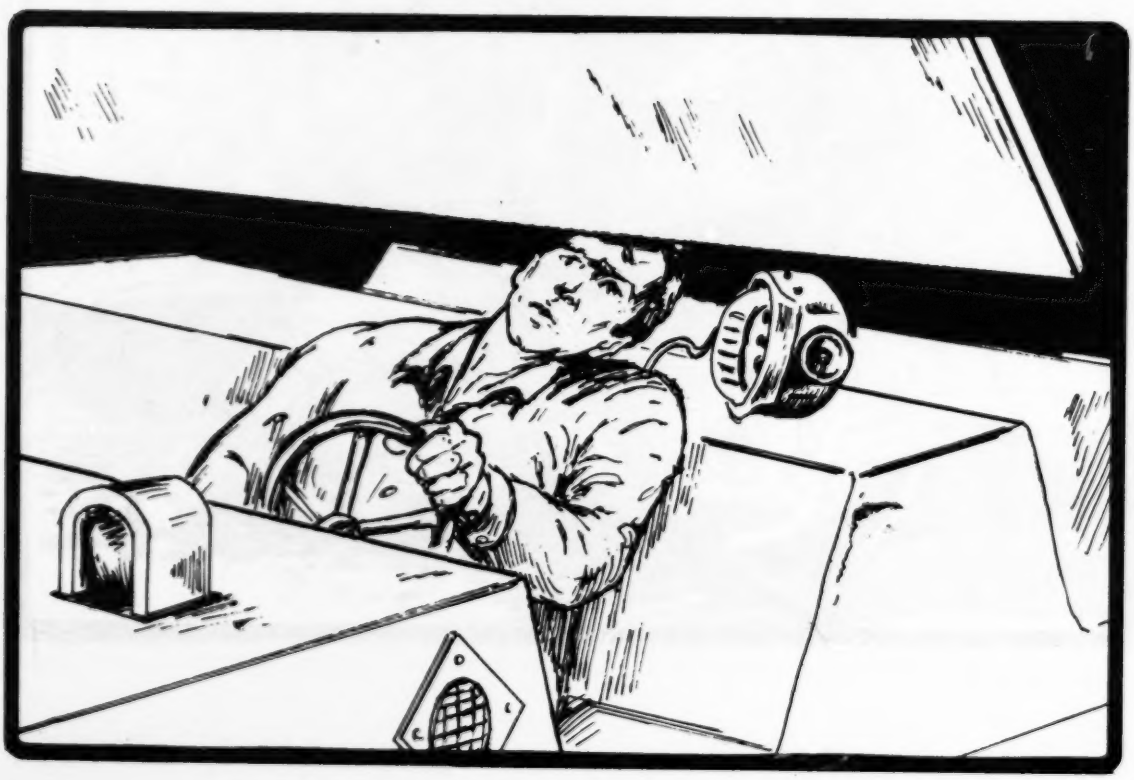
A day shift mine manager and two general inside laborers had been doing repairs where a bus and a supply trailer had derailed. The mine manager was operating a personnel carrier and following the two inside laborers who were in another personnel carrier. The mine manager was 200 to 300 feet behind the laborers, travelling in the same direction. It was necessary to pass through a set of air-operated air lock track doors. When the laborers arrived at the outby door they proceeded through not activating the switch so that the mine manager could pass through and close the door. When they arrived at the next switch, the laborers activated it, opening the inby air lock door and passed through this door. The switch to close the inby air lock door was located about 136 feet inby. Not realizing that the mine manager was close behind them, one of the laborers reached up and activated the switch to close the inby air lock door. As the door closed, the bottom edge of the top hinged door struck the mine manager pinning him against the frame of the personnel carrier, resulting in fatal crushing injuries.

1. Emphasis should be placed on communications to ensure a positive knowledge of the location of affected persons.
2. Procedures for opening and closing doors should be established and strictly enforced.

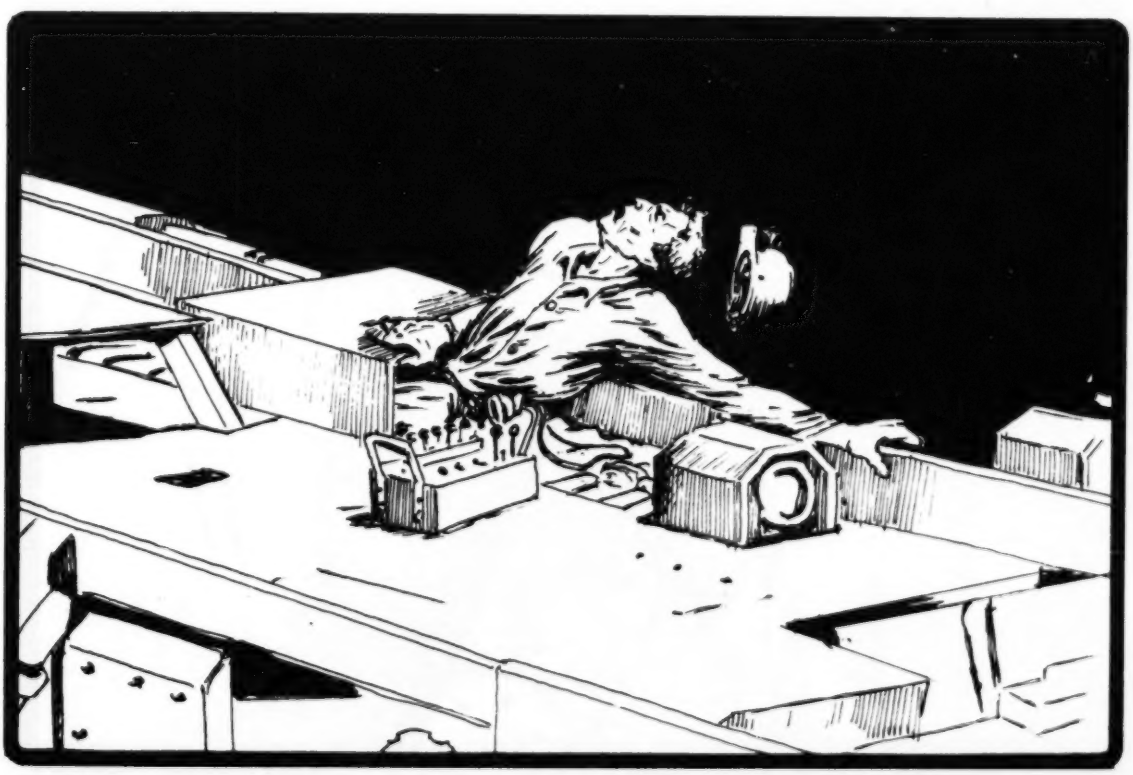
An electrician was repairing a continuous miner when he became caught in the conveyor chain and was fatally injured.

1. Remove equipment from service before performing maintenance.
2. Prior to operating remote control equipment, be sure to place yourself in a safe location.

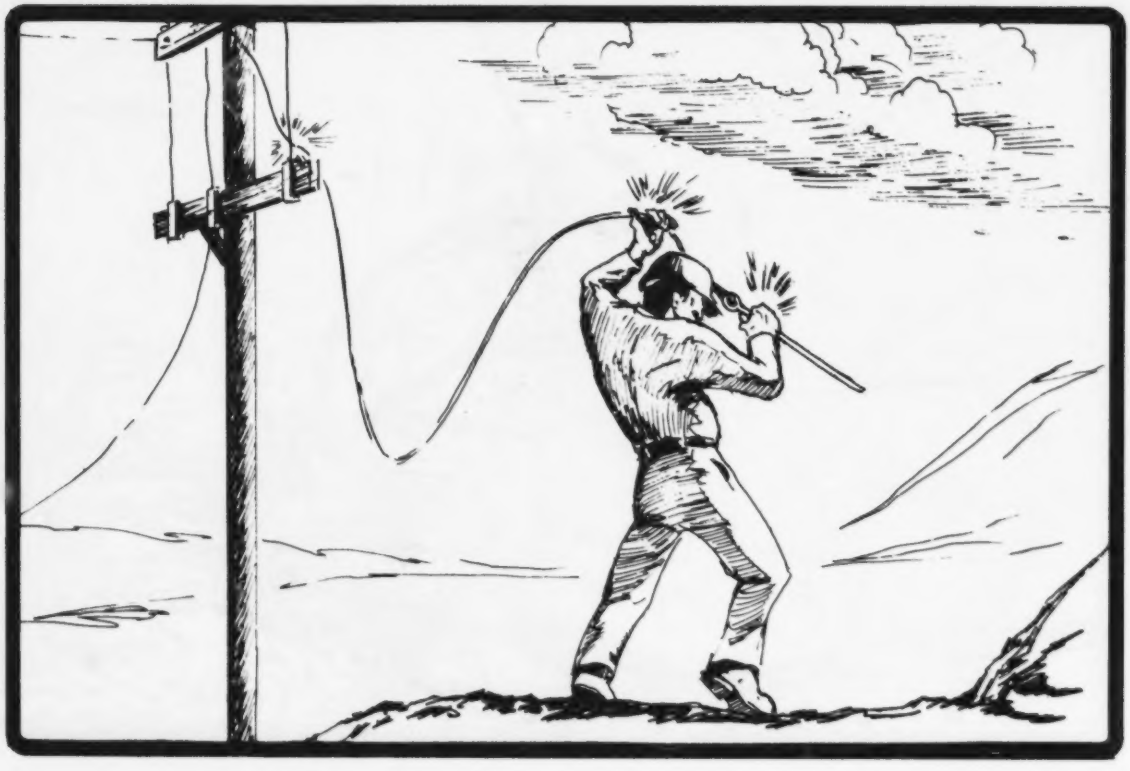
A guy wire attached to a high voltage power line support pole was dislodged from the ground anchor by the raised bed of a passing dump truck. A surface general laborer was assisting the truck driver in removing the guy wire from the roadway when the wire came in contact with the energized high voltage line, resulting in fatal injuries to the general laborer.

1. Attach pole guy wires securely to the system ground or use insulators.
2. When insulators are installed, they must be located below or extend below all high voltage lines supported by the pole.
